Physical Characterization of Kibalagon Creek Catchment Basin

ABSTRACT

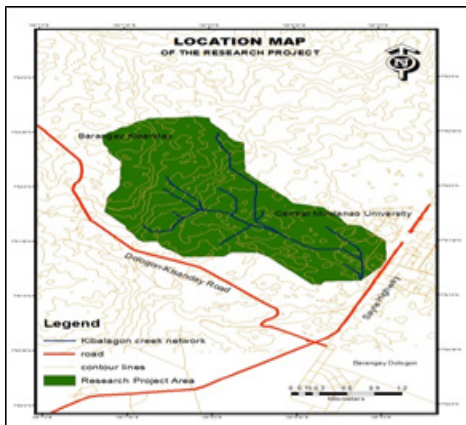
Figure 1a. Location Map of Kibalagon Creek Catchment Basin

The project was conducted from January to December 2013. The creek catchment basin is located at Maramag, Bukidnon at coordinates North latitude 7°50'30" to 7°53'00" and East longitude 125°1'30" to 125°3" (Figure 1a). It has a total area of 464.3 hectares and covers portion of barangay Dologon specifically the southern part of CMU and portion of barangay Kisanday. The eastern part of the basin is bounded by Sayre highway and Dologon-Kisanday barangay road on the southwestern part.

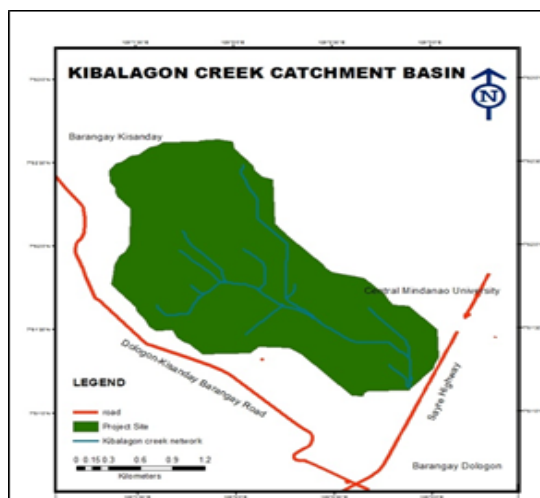
Figure 2. Kibalagon Creek Catchment Basin

The Kibalagon Creek catchment basin has a total area of 464.3 hectares with a perimeter of 9910 meters. It has an axial length of 3711.87 meters with an average width of 1744.76 meters. Its elongation ratio is 0.34 (Table 1 and Figure 2).

The Kibalagon catchment basin's small area is easily affected by the amount of rainfall which results in flash floods of the low-lying areas. Considering the basin steep terrain, a high portion of precipitation become surface flow which rapidly flows towards the Kibalagon creek resulting in flooding at CMU.

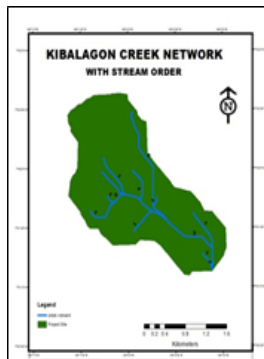
Figure 6. Creek Network with Stream Order

The Kibalagon Creek drains the surface runoff from the upland at the western side and joins the Taganibong Creek at the lowland of the eastern side. It is a tributary of Pulangui River and eventually drains into the Mindanao River. The creek has a total length of 8610 meters consisting of 12 streams. Three streams are classified as a perennial stream, and the other nine streams are classified as either intermittent or ephemeral streams (Figure 6). The creek's main channel is about 2800 meters. It is a third order stream, and the drainage pattern is dendritic. The drainage density is 18.55 meters per hectare resulting in about three streams per one hundred hectares, and the average stream slope is 0.006 (Table 5). Three water sources forming the three perennial streams are (a) Source 1 located at 7°51'50" N latitude and 125°1'40" E longitude; (b) Source 2 at 7°51'45" N latitude and 125°2'05" E longitude; and (c) Source 3 at 7°52'10" N latitude and 125°2'10" E longitude. The catchment basin has a measured mainstream length is 2.5 kilometers and gradient or basin relief ratio of 0.069. The computed lag time (TL) and time of concentration (TC) are 1.15 hours and 1.64 hours, respectively. This indicates that surface runoff reaches the point of interest at the CMU Commercial Complex area on a lapse of 1.64 hours after it heavily rains at the upper part of the catchment area with time to peak at 1.47 hours. The peak runoff rate is 0.76 cms per mm excess of rainfall.
