Original Research

Indicator-Based Assessment of Seismic Vulnerability Factors in Spanish Colonial Heritage Churches in Bohol, Philippines

Citation: Oros, R., & Opon, J. (2025). "Indicator-Based Assessment of Seismic Vulnerability Factors in Spanish Colonial Heritage Churches in Bohol, Philippines." *CMU Journal of Science*. 29(2), 84

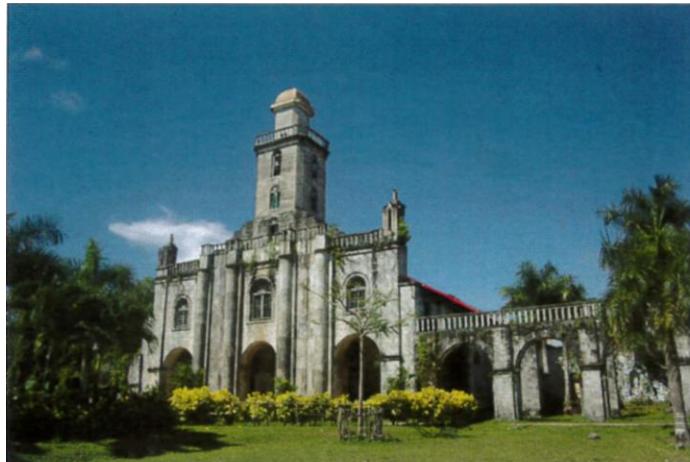
Figure 1. (a) Façade and (b) floor plan of the Parish Church of Santa Monica – Alburquerque, Bohol (Courtesy of National Museum of the Philippines).

The Parish Church of Santa Monica in Alburquerque, completed in the late 19th century, stands as a notable example of Spanish colonial ecclesiastical architecture in the Philippines. The church follows a cruciform plan (Figure 1(b)) with wide transepts, thick unreinforced coral stone masonry walls, and a neoclassical façade accentuated by classical pilasters and cornices. Its bell tower, integrated into the façade, functions as both an architectural focal point and a liturgical feature (Figure 1(a)). During the 2013 Bohol earthquake, the structure sustained only minor damage and was later restored in accordance with national heritage conservation standards [14].

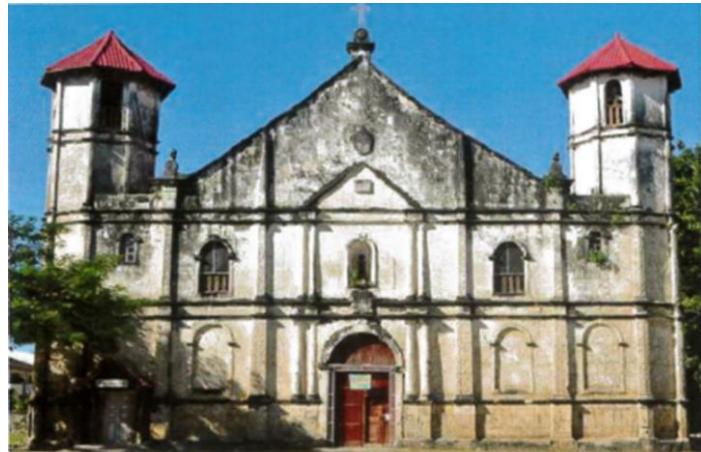
Figure 2. (a) Façade and (b) floor plan of the Parish Church of San Nicolas de Tolentino – Dimiao, Bohol (Courtesy of National Museum of the Philippines).

side buttresses providing lateral stability (Figure 2). Despite its age, the structure sustained only minor damage during the 2013 Bohol earthquake and was later restored in compliance with national heritage conservation protocols [14].

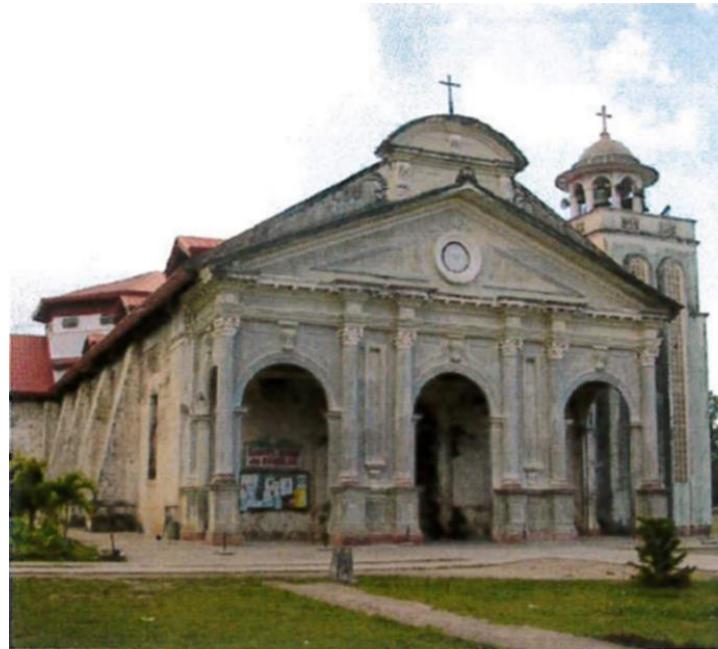
Figure 3. (a) Façade and (b) floor plan of the Parish Church of San Agustin – Panglao, Bohol (Courtesy of National Museum of the Philippines).

The San Agustin Church in Panglao Island, Bohol, follows the same cruciform layout (Figure 3) as the other churches and is primarily constructed from locally sourced coralline limestone, reflecting Spanish colonial building traditions in coastal areas of the Philippines. Architecturally, it is distinguished by its prominent portico façade and intricately frescoed ceilings that blend European religious motifs with Filipino artistic expression. During the 2013 Bohol earthquake, the church sustained moderate structural damage, including masonry cracks and partial detachment of ornamental elements. Subsequent restoration and retrofitting works were carried out to enhance its structural integrity and ensure the preservation of its cultural and historical value [14].
